DEPARTMENT OF TRANSPORTATION

Contract #: 04-0120F4Cty: SF/ALA Rte: 80 PM: 13.2/13.9File #: 69.28**WELDING INSPECTION REPORT****Resident Engineer:**Pursell, Gary**Address:** 333 Burma Road**City:** Oakland, CA 94607**Report No:** WIR-008921**Date Inspected:** 17-Sep-2009**Project Name:** SAS Superstructure**OSM Arrival Time:** 700**Prime Contractor:** American Bridge/Fluor Enterprises, a JV**OSM Departure Time:** 1900**Contractor:** Zhenhua Port Machinery Company, Ltd (ZPMC), Changxing Island **Location:** Shanghai, China**CWI Name:** Chen Xi**CWI Present:** Yes No**Inspected CWI report:** Yes No N/A**Rod Oven in Use:** Yes No N/A**Electrode to specification:** Yes No N/A**Weld Procedures Followed:** Yes No N/A**Qualified Welders:** Yes No N/A**Verified Joint Fit-up:** Yes No N/A**Approved Drawings:** Yes No N/A**Approved WPS:** Yes No N/A**Delayed / Cancelled:** Yes No N/A**Bridge No:** 34-0006**Component:** OBG Crossbeams**Summary of Items Observed:**

OBG CROSS BEAM CB1

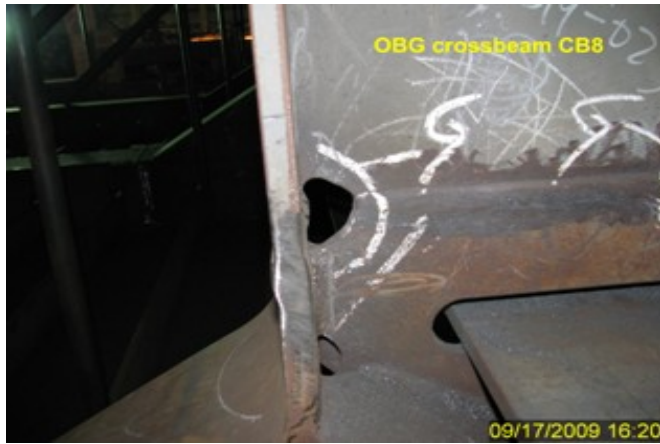
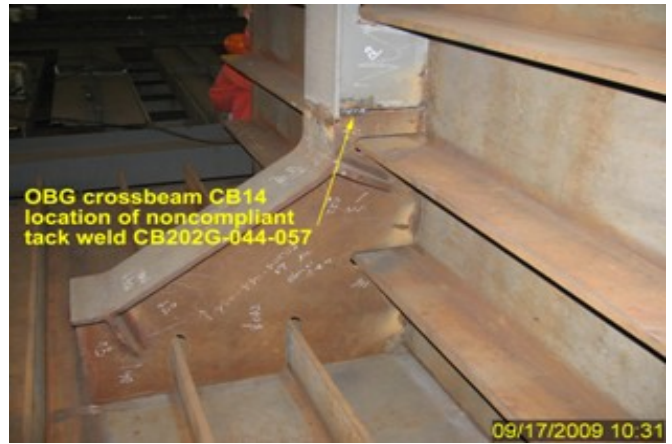
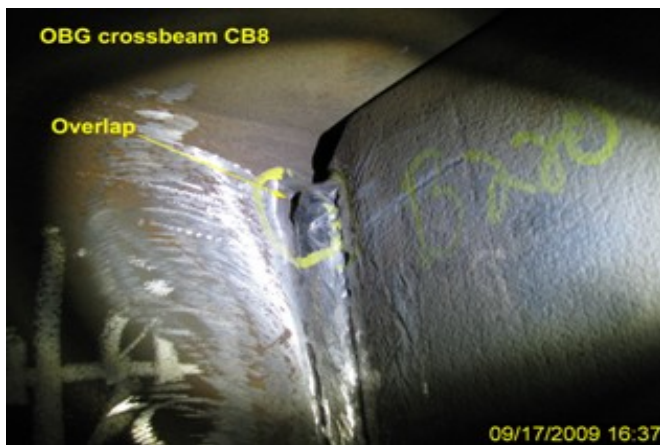
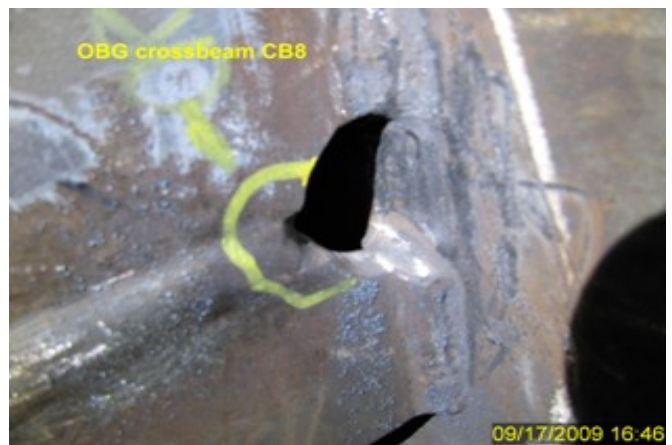
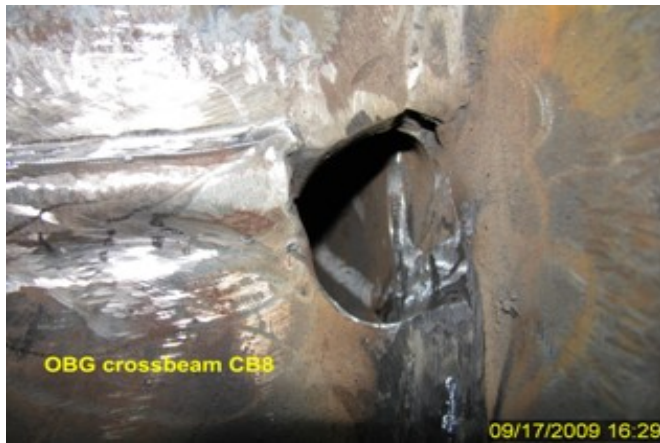
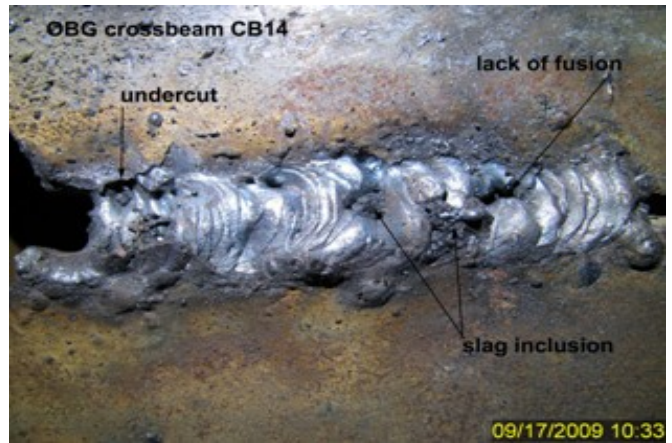
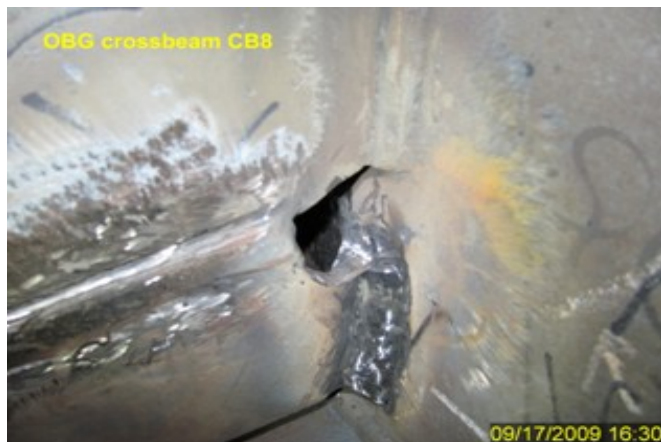
This QA observed ZPMC personnel trimming the stock material off of the deck, side and bottom panels on the north and south ends of this crossbeam. QA noted that the worker was using automated, gear driven thermal cutting equipment. No other significant work was observed on this crossbeam during the time QA was present.

During random in process inspection of this crossbeam this QA observed several cope holes in the floor beam diaphragms and various welds that do not appear to comply with the contract documents. Fabrication of this crossbeam is still in process and has not yet been released to QA for final inspection. This QA marked the areas in question for the contractors QC to inspect and evaluate. The attached photos of these discrepancies are intended to capture the in-process workmanship being performed on this component.

This QA observed ZPMC qualified welding personnel identified as 220688 perform FCAW welding on weld joint identified as CB202A-009-002. ZPMC QC identified as Mr. Liu Cheung Gang was present to monitor the welding process. The welding parameters as measured using QC's calibrated instruments appeared to be in general compliance with WPS-B-T-2232-Tc-U4b-F.

During random in process inspection of the joint fit up of this crossbeam this QA observed that at least one tack weld at joint identified as CB202G-044-057 did not appear to comply with the contract documents. This QA informed ZPMC QC inspectors of the deficient tack weld. The QC inspectors concurred with QA and instructed the workers in the area to grind the tack and re-tack the joint prior to welding. This tack weld had not yet been repaired prior to QA departing the area. The attached photo of this tack weld is intended to capture the in-process workmanship being performed on this component.
